December 3, 2020

Project PS1918096B

Subject: Geotechnical Engineering Supplement No. 4: East Stairway Construction
Central Kitsap High School and Middle School Campus Redevelopment
3700 NW Anderson Hill Road/10130 Frontier Place NE, Silverdale, Washington

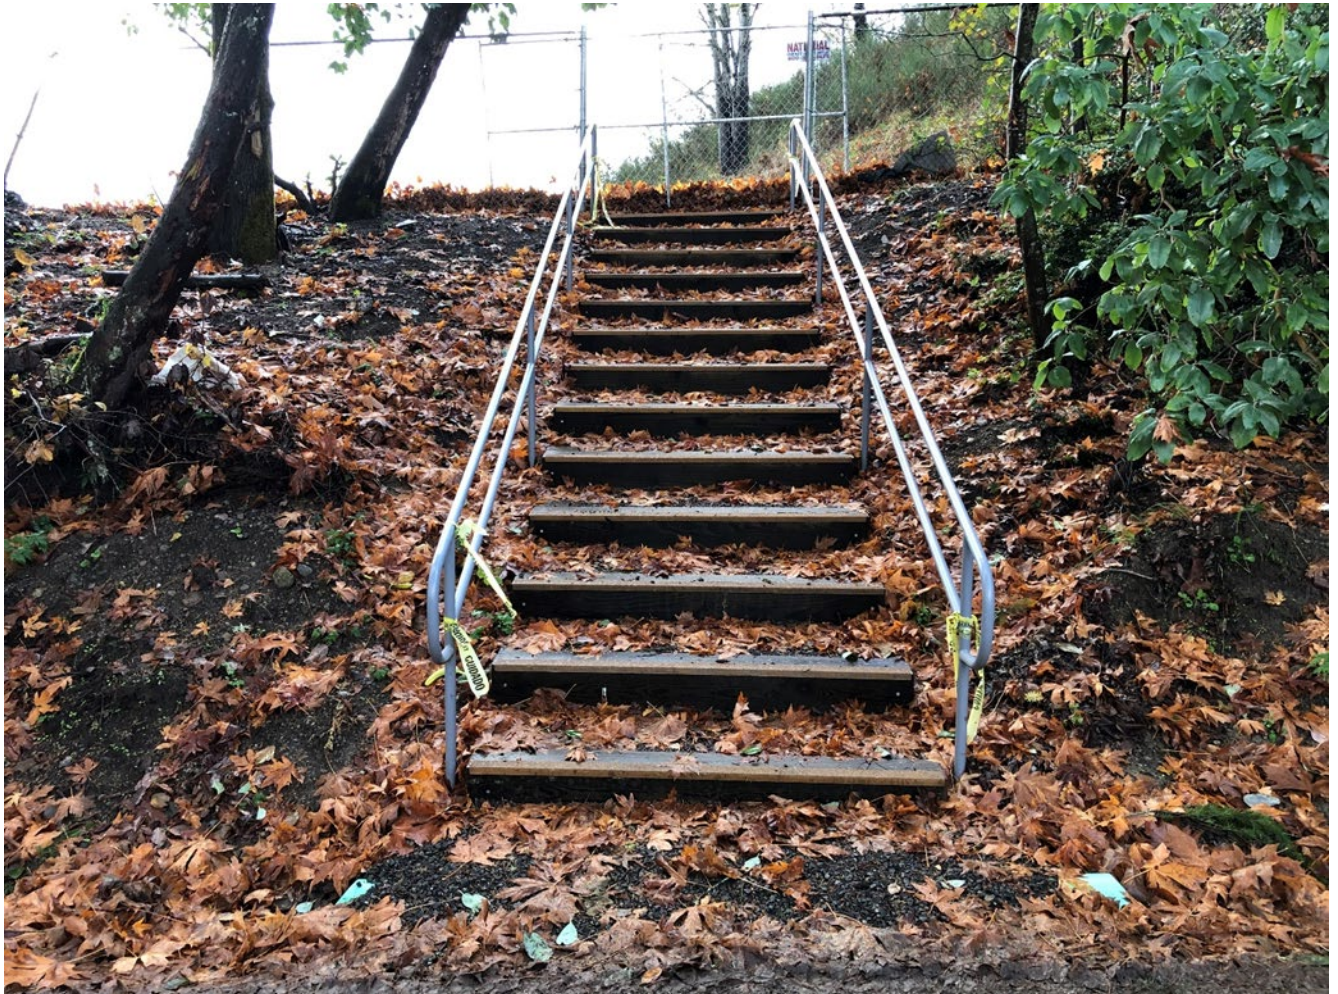
A Wood geotechnical engineer visited the school grounds on November 17, 2020, to evaluate the visible condition of the east and west slopes. We observed that the stairs were constructed within shallow cut segments on the east slope and were placed at a slight angle to facilitate rainwater runoff. A small culvert, consisting of polyvinyl chloride (PVC) pipe, was installed at the bottom landing, adjacent to Dahl Road NW, and covered with gravel (Photo 1). We understand that the PVC pipe culvert was installed in order to accommodate water flow along an existing north-south ditch line at the base of the slope.

Photo 1: Stairway constructed on east slope; view facing west.

We used a 0.5-inch-diameter, steel T-probe to evaluate the relative density of surficial soil adjacent to the stairway. On either side of the stairway, we generally observed a thin layer (approximately 0.5 foot) of loose material, underlain by relatively dense soil. The loose surficial layer likely consists of spoils from the stairway excavation that were placed back onto the slope. We observed that the construction of the stairway did not significantly disturb the native slope soils (e.g., large, unsupported cuts were not required to install the stairway). Likewise, we did not observe features such as surficial creep on the east or west slope.

We recommend that the PVC pipe at the bottom landing of the stairway be regularly cleaned of leaves and other organic debris to maintain water flow along the ditch line. In accordance with KCC 19.400.435(A), we recommend that any areas that were cleared and grubbed during construction (i.e., on either side of the stairway) be revegetated with native plants to promote erosion control.
