Mud Bay Geotechnical Services, LLC

Job: 1328-KIT

Subject: 9781 Enchantment Ave NW,
Silverdale, Washington 98383
Foundation Settlement Geotechnical Report
Parcel #5201-000-032-0008

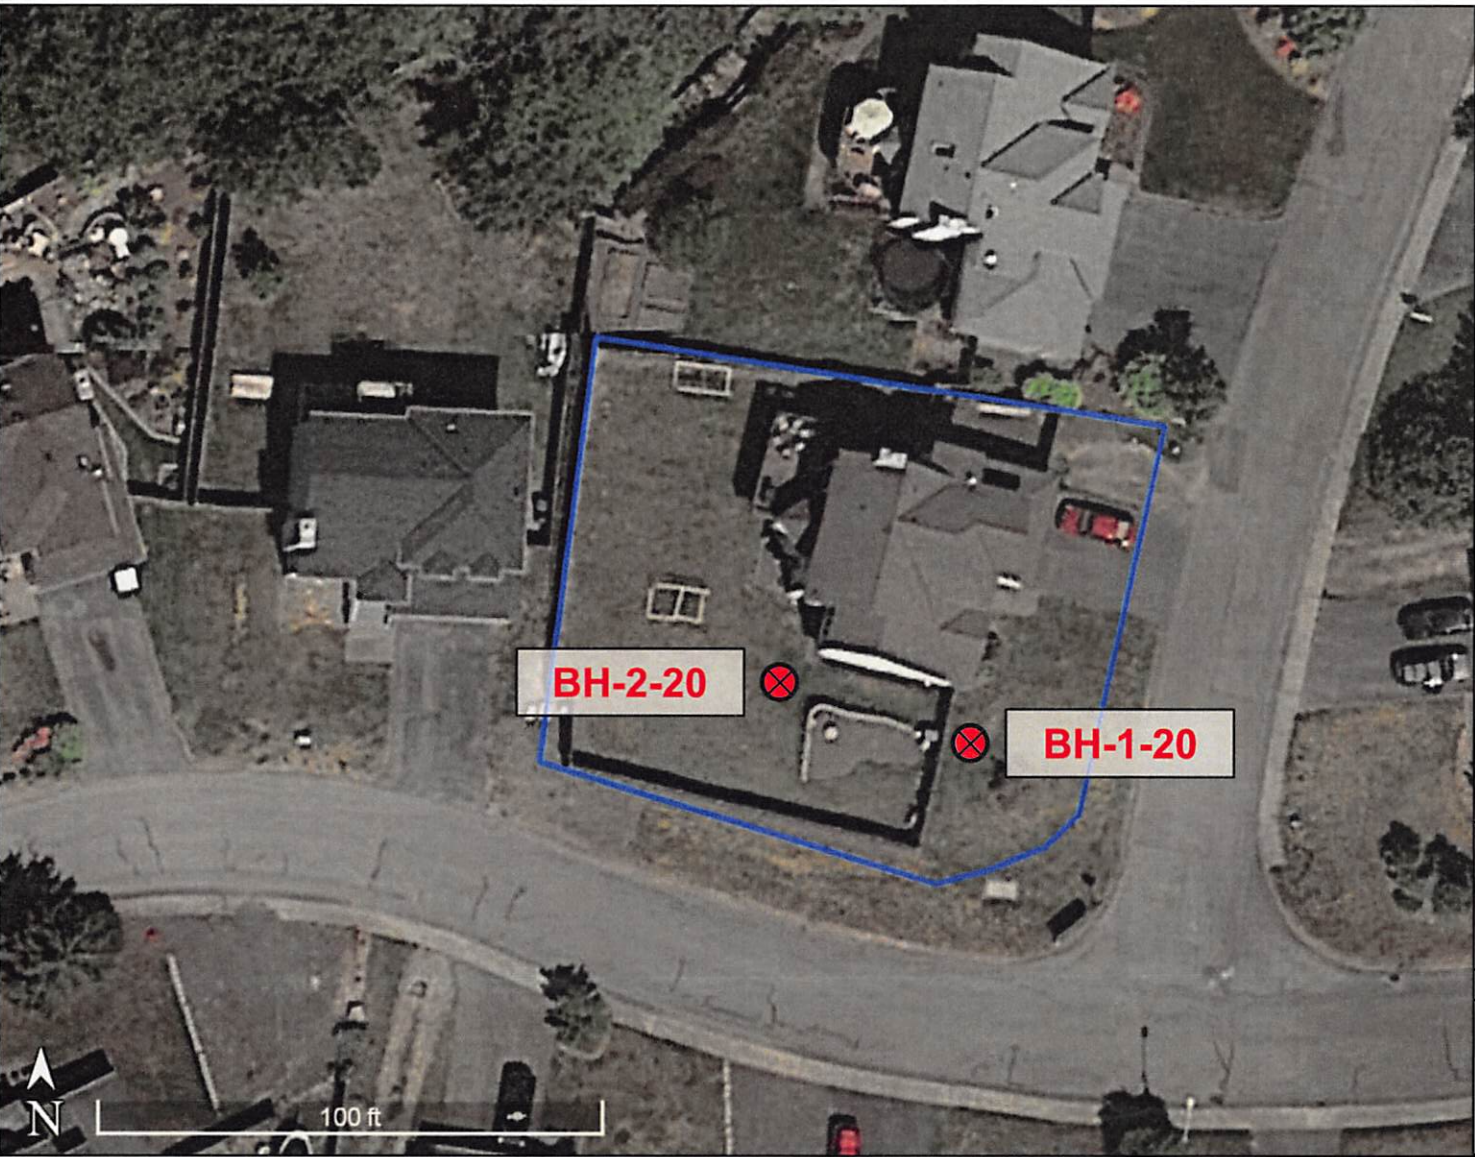
Figure 4: Site Exploration Map

As part of the geotechnical investigation, two shallow hand augured borings were performed at the approximate locations shown on Figure 4. The borings were completed using a Humboldt Manufacturing model H-4414QC hand auger with a 4-inch diameter bucket tube sampler. In situ testing was performed at selected depths using a Humboldt Manufacturing model H-4202A dynamic cone penetrometer to estimate the density of the soil. The dynamic cone penetrometer uses a 15-lb steel mass falling a height of 20-inches onto an anvil to penetrate a 1.5-inch diameter 45-degree cone tip seated into the bottom of the hole.

Based on the soils encountered in BH-1-20, the front yard of the home consists of an upper 6-inches of topsoil underlain by *medium dense, moist, grayish-brown, well-graded gravel with silt and sand (GW-GM)* to a depth of 29-inches. From 29 to 39-inches, a layer of *moist, gray-blue silt with heavy mottling (ML)* was noted, indicating interaction with groundwater. Immediately underlying this unit was a layer of *dense, wet, tan, well-graded gravel with silt and sand (GW-GM)* to the final depth of boring at 48-inches. A large cobble obstruction impeded further digging. Groundwater seepage was noted at a depth of 39-inches at the contact between the fine-grained ML unit and coarser GW-GM layer.

BH-2-20 was performed off the southwestern corner of the home, where less foundation settlement has occurred. The findings in this boring reveal that the subsurface consists of an upper 4-inches of topsoil underlain by *loose, moist, tan, well-graded sand with silt and gravel (SW-SM)* to a depth of 42-inches and *very dense, moist, brown, concreted sandy silt (ML)* to the final depth of boring at 48-inches.

BH-1-20 and BH-2-20 were used to interpret the subsurface conditions. Based on the conditions observed in the borings, we recommend installing the push piers to a minimum depth of 7 feet below the current ground surface, or to a pressure of 2,400 psi, whichever is deeper. Load testing should be performed to 2.0 times the design load on a minimum of 1 push pier in accordance with ASTM Standard D1143-81.
