Reference: Limited Geological Sites Reconnaissance Kitsap County Parcel No. 282302-4-048-2001 and 282302-4-049-2000 10631 (and Adjacent Parcel) Orchard Avenue SE Olalla, Washington

Resolve Environmental and Geotechnical, Incorporated (Resolve) is pleased to provide this letter report for the limited geological site reconnaissance at the above-referenced properties. Resolve understands that the object of the investigation was to perform a limited visual inspection of the sites and geologic conditions wherein proposed future construction will be undertaken. We understand that the reconnaissance is related to Kitsap County permitting requirements.

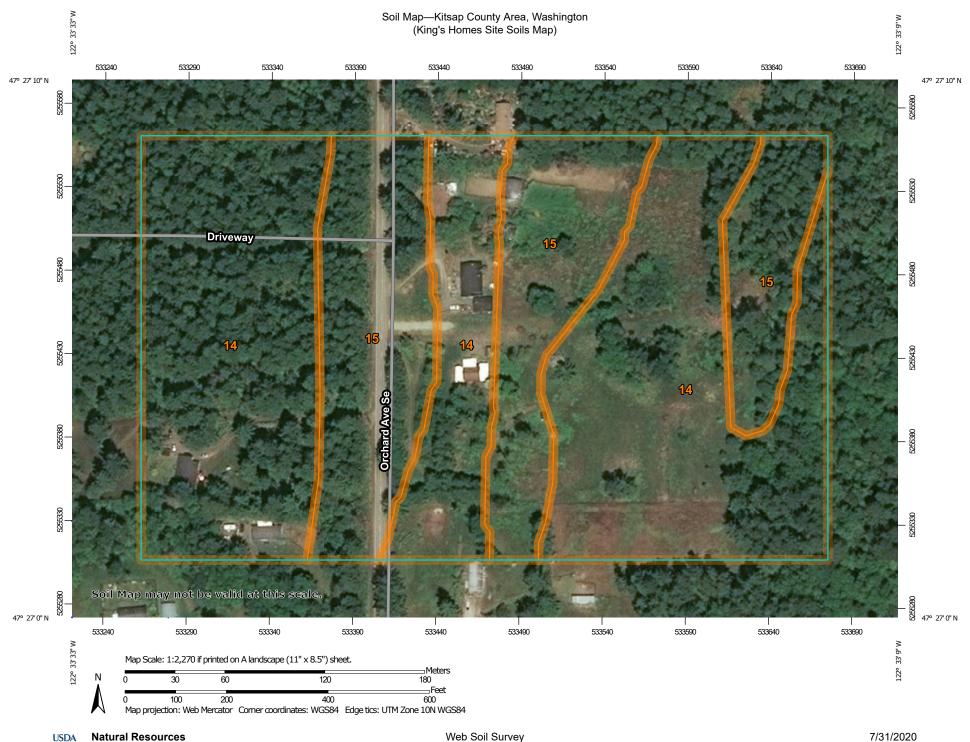
USDA INFORMATION

Natural Resources Conservation Service Web Soil Survey National Cooperative Soil Survey Permit Number: 20-03414 7/31/2020 Page 1 of 3
